Manhole Inspection Summary

Manhole # S29CC_016MH

Insp Date: **7/18/08 9:50 AM**

Location Address: **1314 ETTING ST**

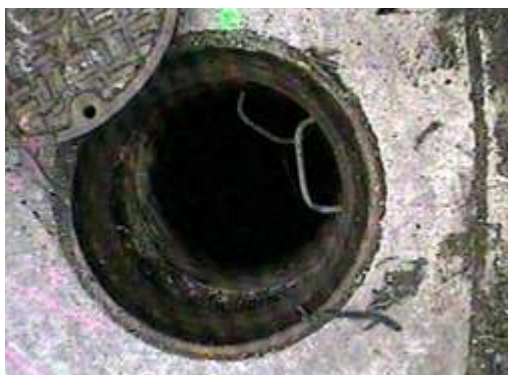
Top View

Frame Offset: **3** (in.) Condition: ☒ Sound ☐ Cracked ☐ Leaks

FRAME OFFSET

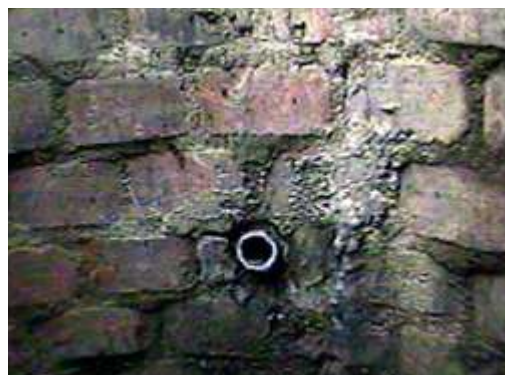
POSSIBLE ILLICIT CONNECTION

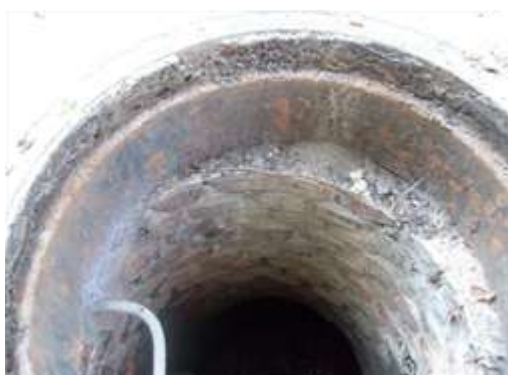
Defect 1

Condition: ☐ Sound ☒ **Cracked** ☐ Root Intrusion ☐ Loose Brick ☐ Deteriorated

Infiltration: ☐ None ☒ **Joint** ☒ **Cracks** ☐ Mortar ☒ **Roots** ☐ Wall

CHIMNEY LOOSE BRICK CRACKS AND
ROOT INTRUSION

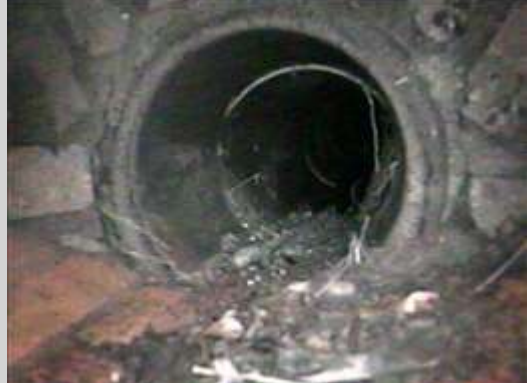
12 O'Clock Outflow

8 in. Circular Gravity Sewer
Pipe Out @ 12 O'Clock

Pipe Material: **Clay** ☐ Pipe Lined

Invert Depth: **9.48** (ft.) Flow Characteristics: **None**

Infiltration: **None** Pipe Seal Cond: **Sound**
